Pulmonary Bone Cement Embolism following Pedicle Screw Instrumentation with Bone Cement Augmentation for a Burst Fracture of L1 in a Non-Osteoporotic Spine

Jose Manuel F. Ignacio¹ and Sharon D. Ignacio²

¹Department of Orthopedics, College of Medicine and Philippine General Hospital, University of the Philippines Manila

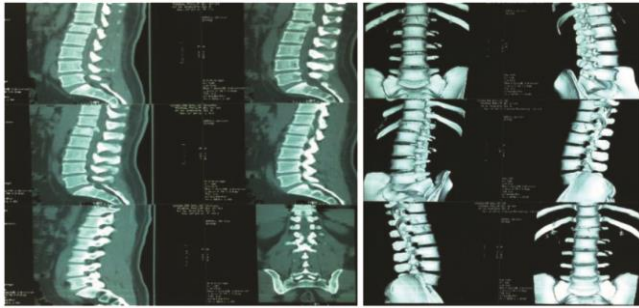
Figure 1. Sagittal and 3D reconstruction of injury studies showing a burst fracture of L1 with a fragment retropulsed into the spinal canal

A 34-year-old seaman was transferred from an overseas hospital for postoperative management and rehabilitation of a spine injury. His history started three weeks prior to admission when, while working on a ship's deck, he fell backwards landing onto a lower deck. He experienced severe back pain and narrates that he could not move his lower extremities. He was transferred from his ship to a hospital in a country nearby. The patient developed bladder and bowel incontinence after the injury although he noted that his lower extremity motor function began returning to his left toes even before his operation which took place three days after his injury. The patient had CT scan and MRI studies done on this admission (Figures 1 and 2).

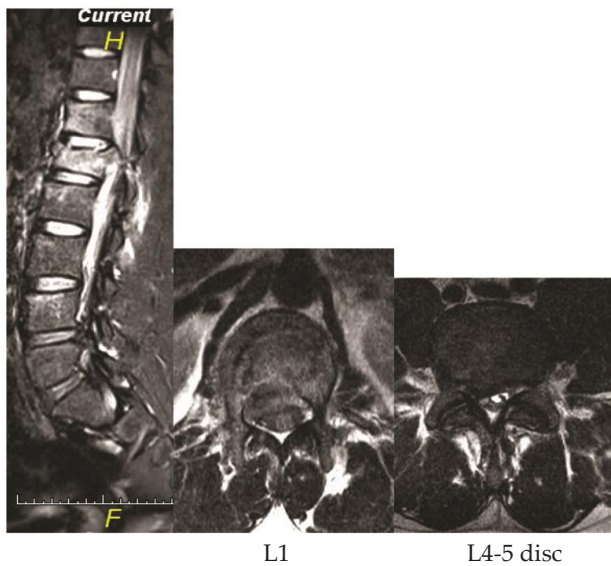
Figure 2. MRI image showing the L1 burst fracture and a central and right sided disc herniation at the L4-5 disc

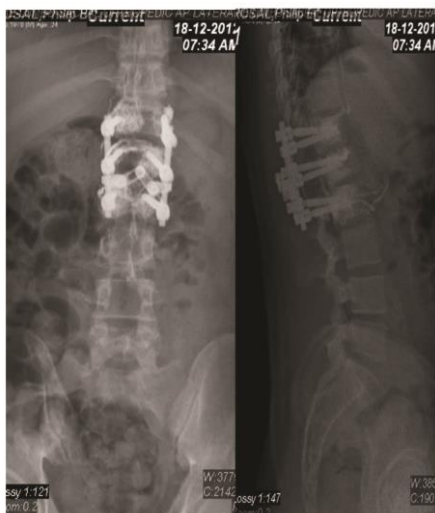
Figure 3. Radiographs done upon admission showing serpentine opacities at the perivertebral areas

Initial radiographs revealed pedicle screw fixation of T12-L2 with the screws augmented with bone cement. Aside from these findings, there was the ominous presence of serpentine looking opacities at the perivertebral region as well as over the anterior epidural spaces at the L1-2 areas (Figure 3). Harboring a suspicion of bone cement extravasation into the surrounding vascular structures, further examinations were done including a CT scan of the lumbosacral region with coronal, sagittal and 3D reconstruction. A Chest CT scan revealed cement embolus within the pulmonary artery (Figure 4).

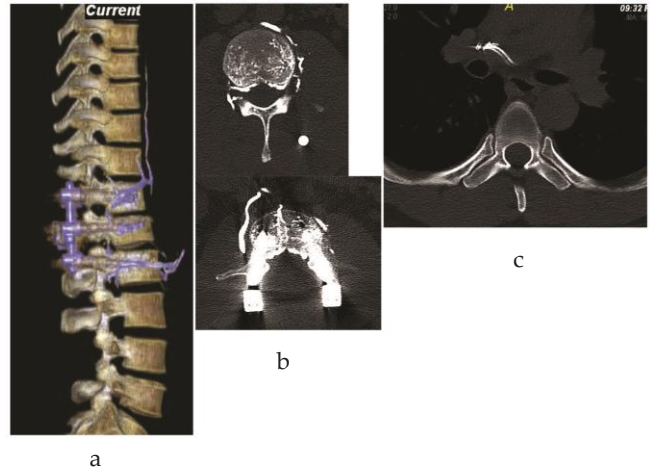
Figure 4. CT Scan studies showing (a) cement extravasation around the lumbar spine and the pathway taken by the cement towards the lungs. (b) Axial images showing cement extravasation from within the body onto the perivertebral plexus via the nutrient and epidural vessels. (c) Bone cement lodged at the pulmonary artery

In this patient being presented, the presence of cement was identified in the epidural and paravertebral plexus of veins as well as within the inferior vena cava and the Hemiazygos vein. The presence in one or the other of these sites as being a sole risk factor in pulmonary cement embolism may not be an accurate observation since, as shown in the axial sequences of the CT scan image, the cement actually extravasated from the inner portion of the vertebral body outwards via the nutrient vessel onto the vertebral plexus (Figure 4a and b). The embolus then proceeded onto the inferior vena cava and the Hemiazygos vein thru the heart and eventually, the pulmonary vasculature (Figure 4c). It is believed by the authors of this report that this is the pathway for the cement in reaching the lungs and that the previous studies cited only the parts which were captured in the CT scan images done on their patients. Likewise, cement formation within the vessels as seen in these extensive CT scan 3D images (Figure 4a) do not necessarily form a continuum as it finds its way towards the central vasculature onto the lungs. There will be areas which will be devoid of cement only later to reappear at a more central site. The extensive documentation of this patients' pulmonary cement embolism, made more graphic by 3D CT scan sequences gives support to the thinking that the pathology and risk factors are not limited to just certain areas where the cement is documented to be present. The mere fact that the cement leaked outside to the paravertebral vasculature means that the cement may already travel towards the lungs.

presented, performing the vertebroplasty with the aim of augmenting the pullout strength of the screw on the vertebral body was in all probability done with the cement in a more liquid phase so that the cement will not harden prior to insertion of the screws. This is the usual technique when inserting cement prior to inserting screws. This is the reason why fenestrated screws were invented. When using screws with a fenestrated design, the surgeon is allowed to insert the screw first and cement can then be applied onto the head of the screw which then brings the cement into the vertebral body by way of a channel within the screw shaft. In this patient, when the cement was injected in a very liquid state, the stage was set for an easy extravasation of the cement outside the confines of the vertebrae and into the surrounding vascular structures.

Despite the presence of pulmonary bone cement embolism, the patient did not show signs of respiratory compromise, and 2D echocardiography showed good cardiac function. Since the patient was asymptomatic, he was simply managed with anticoagulants which was planned for a 6 month course. The patient was subsequently discharged able to ambulate with an ankle foot orthosis for his foot drop which failed to recover and on an intermittent catheterization program for his bladder incontinence.

Management of such conditions are dependent on the location of the emboli and whether the patient is symptomatic or not. In a systematic review by Kreuger, et al., a decision making tree was proposed.⁷ The factors considered are whether the embolus is peripherally or centrally located and if the patient is symptomatic or not. Asymptomatic peripheral emboli are managed by observation. Anti-coagulation treatment is reserved for symptomatic peripheral or asymptomatic central involvement. Surgery is limited only for the symptomatic central or pulmonary types of cement embolization since anticoagulant therapy will not open an occluded vessel. The purpose for anticoagulant therapy is merely to limit the formation of thrombus around the cement.⁹ The paper by Kreuger also mentions reports where surgeons regretted having opened up their patients with central types of emboli presumably due to the difficulty in performing the surgery and all its attendant risks.⁷
